Inspection Report

Property Address:
1 Copperhead Lane
Dover NH 03820

Copperhead Home Inspection, LLC

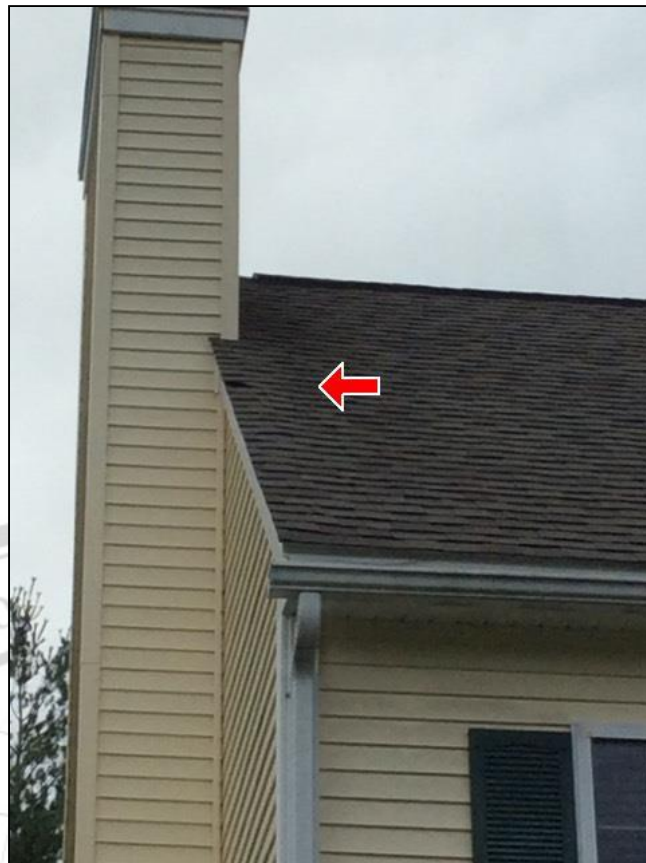
1.0 Item 1(Picture)

1.0 (1) Several shingles were observed curling up on front side of roof near the left edge.

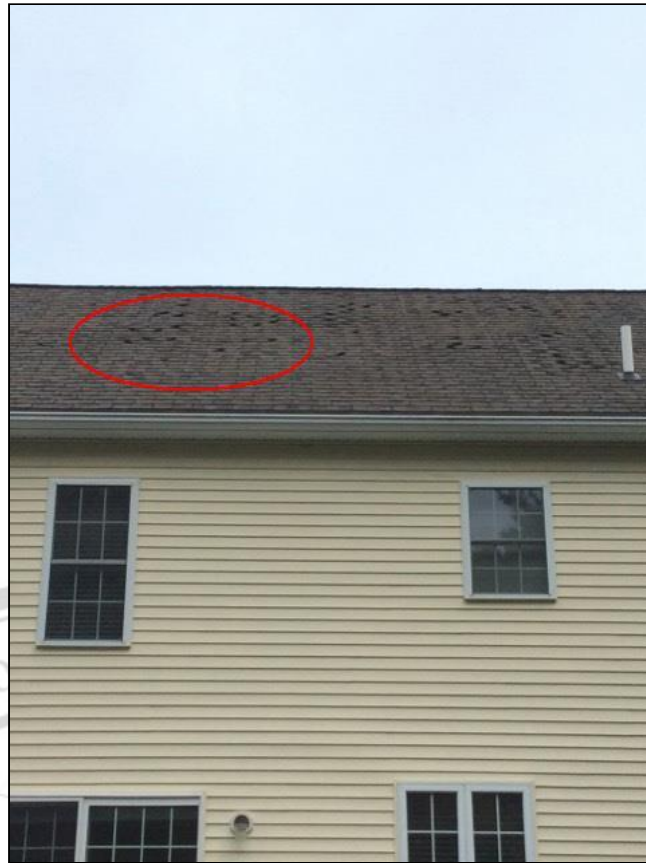
1.0 Item 2(Picture)

1.0 (2) Roof on rear of house is showing signs of deterioration. Rear side of the roof is approaching the end of its useful life. Recommend evaluation by qualified roofing contractor to determine extent of repairs.

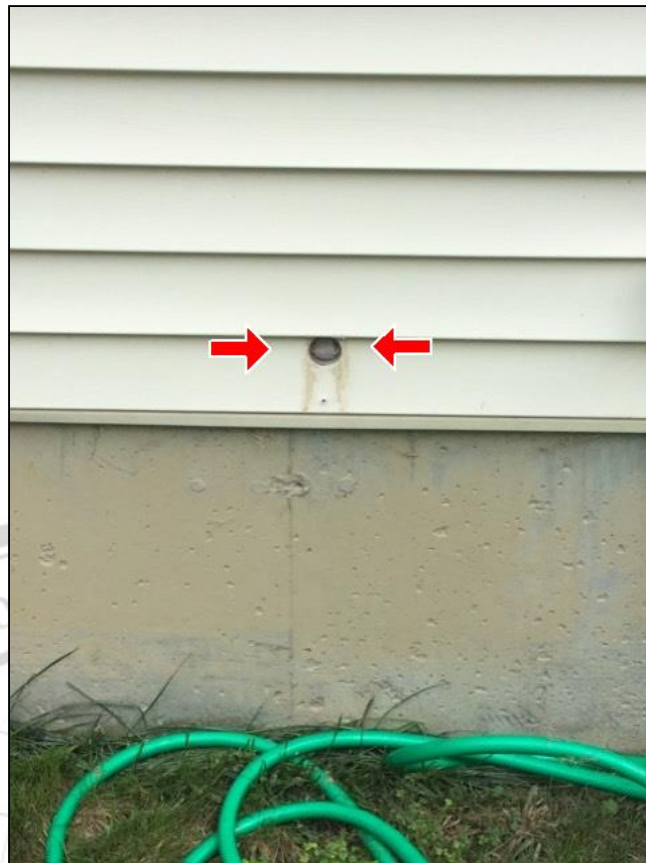
2.0 Item 1(Picture)

2.0 (1) Replace piece of vinyl siding or seal hole to prevent water intrusion.

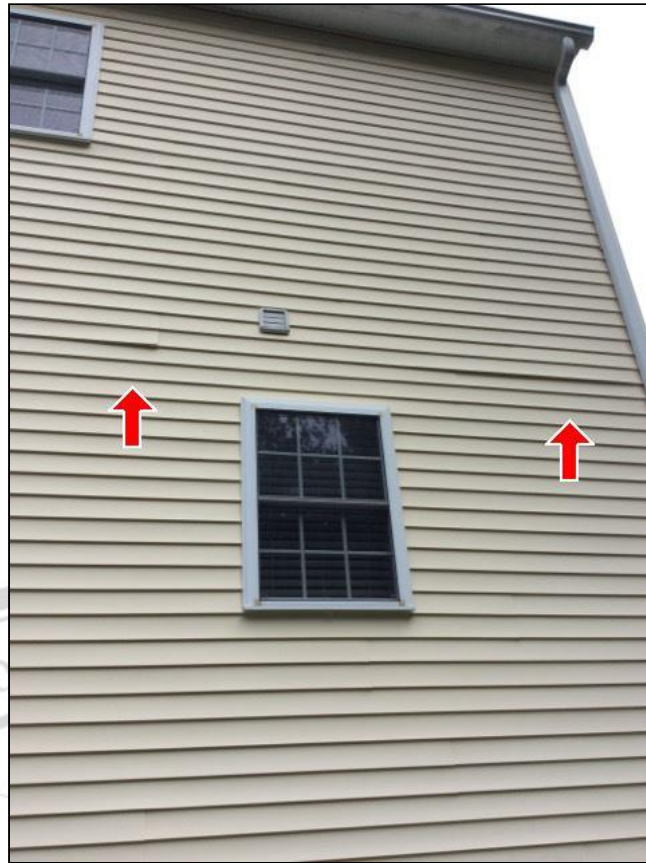
2.0 Item 2(Picture)

2.0 (2) Loose pieces of vinyl siding need to be secured.

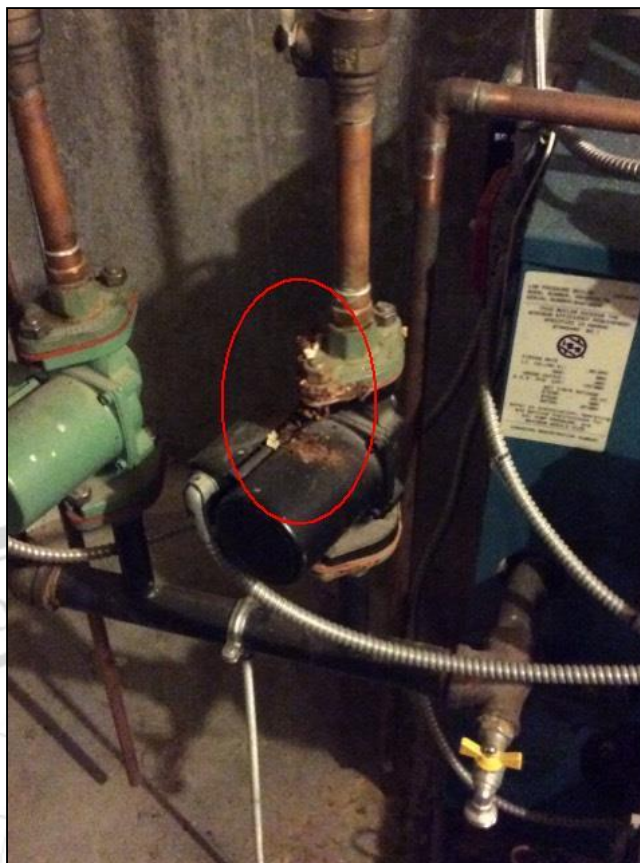
4.3 Item 1(Picture)

4.3 Evidence of leak was observed at black circulator pump on heating system. This circulator was not functioning at the time of the inspection. Recommend the circulator be evaluated by a qualified heating contractor.

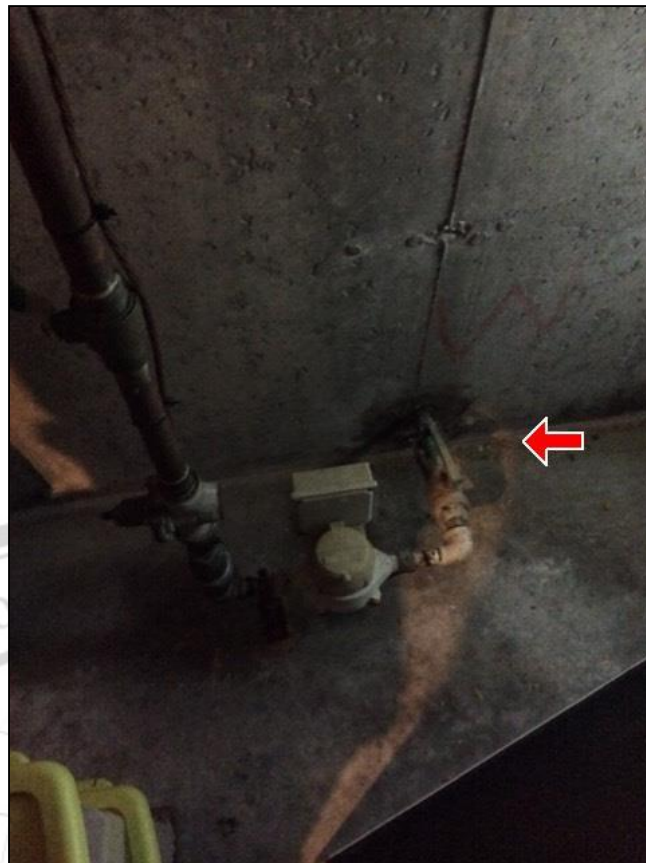
5.3 Item 1(Picture)

5.3 This is your main water shutoff valve

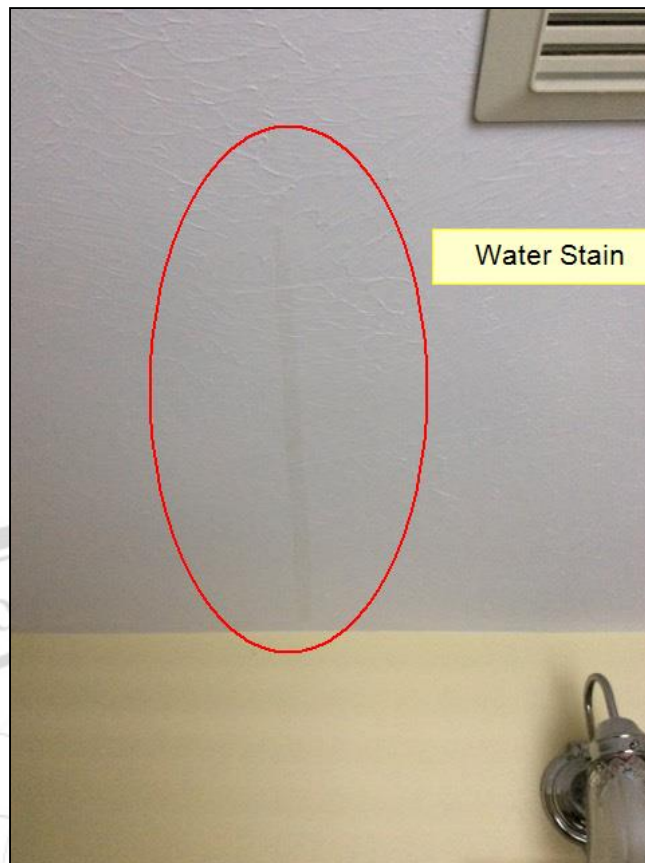
8.0 Item 1(Picture)

8.0 Water stain observed on first floor laundry room ceiling. Ceiling was dry at the time of inspection. Monitor for future problems. Owners reported it was from a previous overflow of toilet.

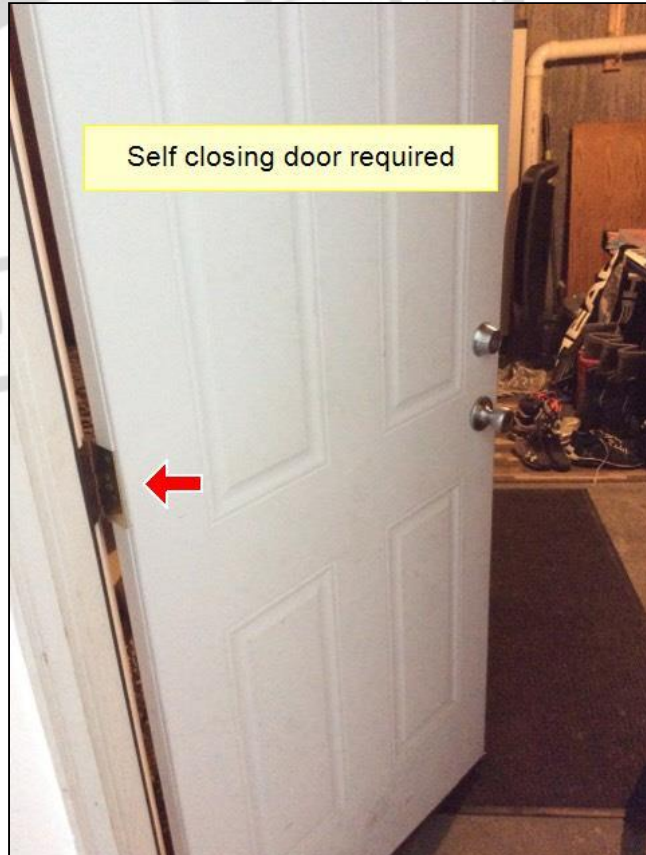
9.4 Item 1(Picture)

9.4 Garage entry door into house should be self closing and latching to provide proper fire separation. Add door closer or spring hinges to provide proper closure.

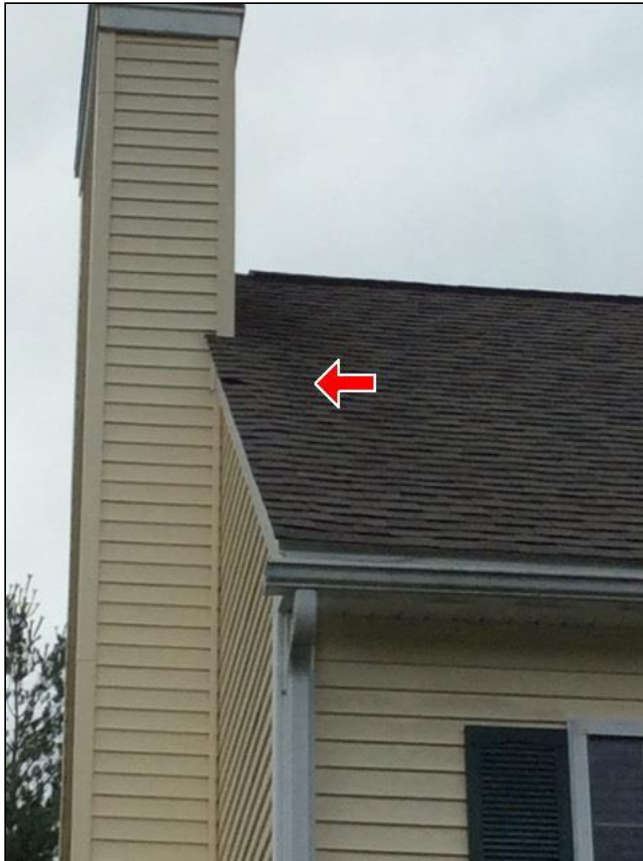
1.0 Item 1(Picture)

(1) Several shingles were observed curling up on front side of roof near the left edge.

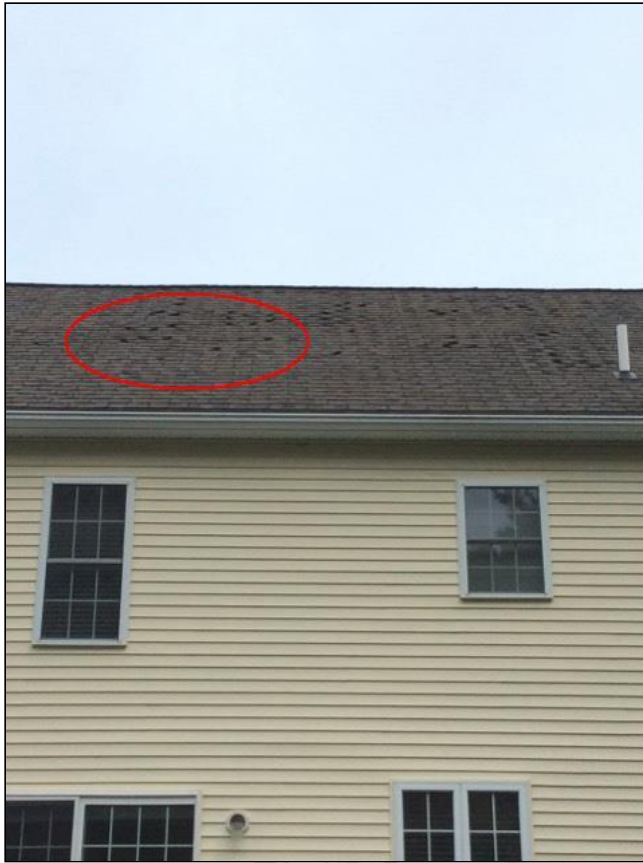
1.0 Item 2(Picture)

(2) Roof on rear of house is showing signs of deterioration. Rear side of the roof is approaching the end of its useful life. Recommend evaluation by qualified roofing contractor to determine extent of repairs.

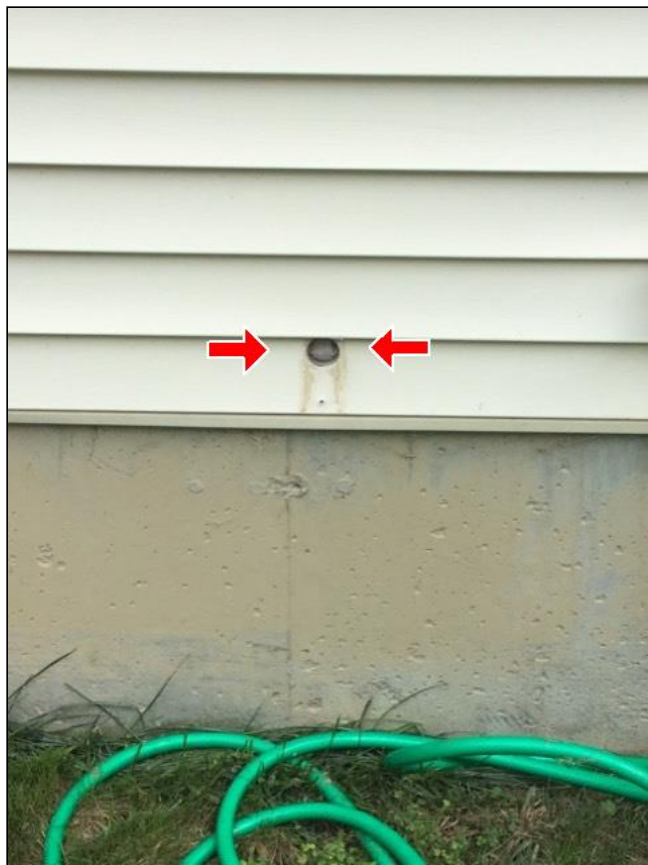
2.0 Item 1(Picture)

- (1) Replace piece of vinyl siding or seal hole to prevent water intrusion.

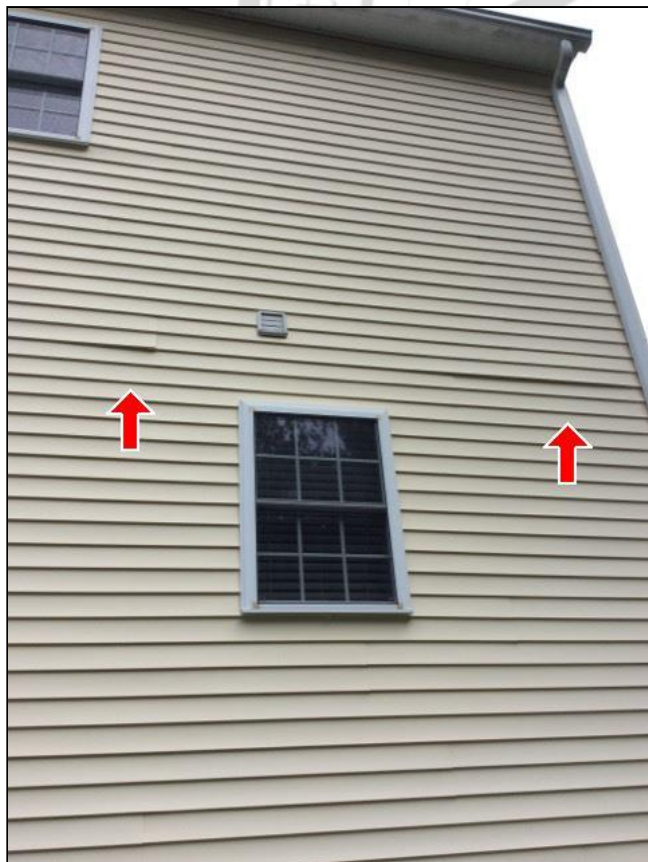
2.0 Item 2(Picture)

(2) Loose pieces of vinyl siding need to be secured.

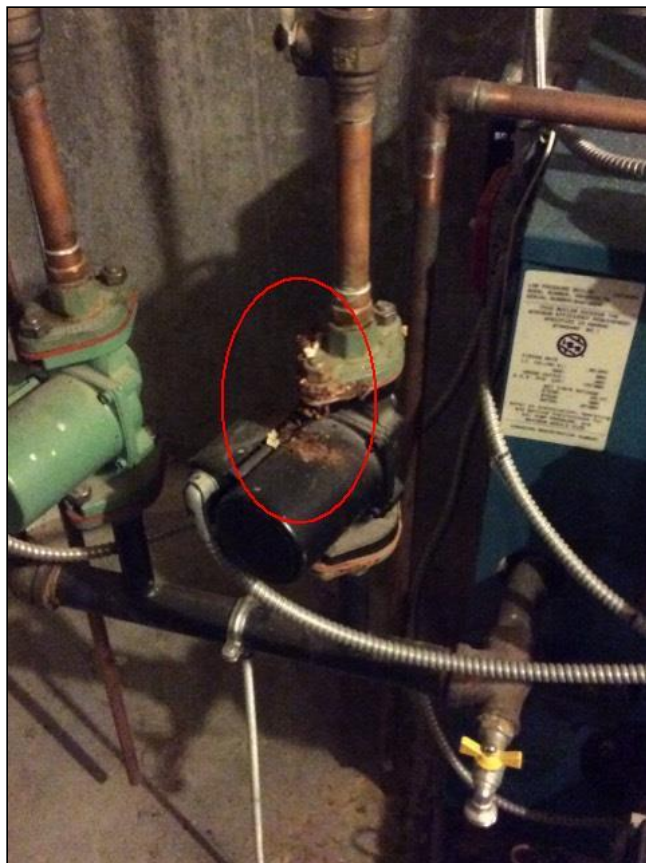
4.3 Item 1(Picture)

Evidence of leak was observed at black circulator pump on heating system. This circulator was not functioning at the time of the inspection. Recommend the circulator be evaluated by a qualified heating contractor.
